DEPARTMENT OF THE ARMY  
ARMY CONCEPT TEAM IN VIETNAM  
APO San Francisco 96384

FINAL REPORT

MILITARY POLICE RIVER/HARBOR SECURITY COMPANY

ACTIV PROJECT No. ACG-73F

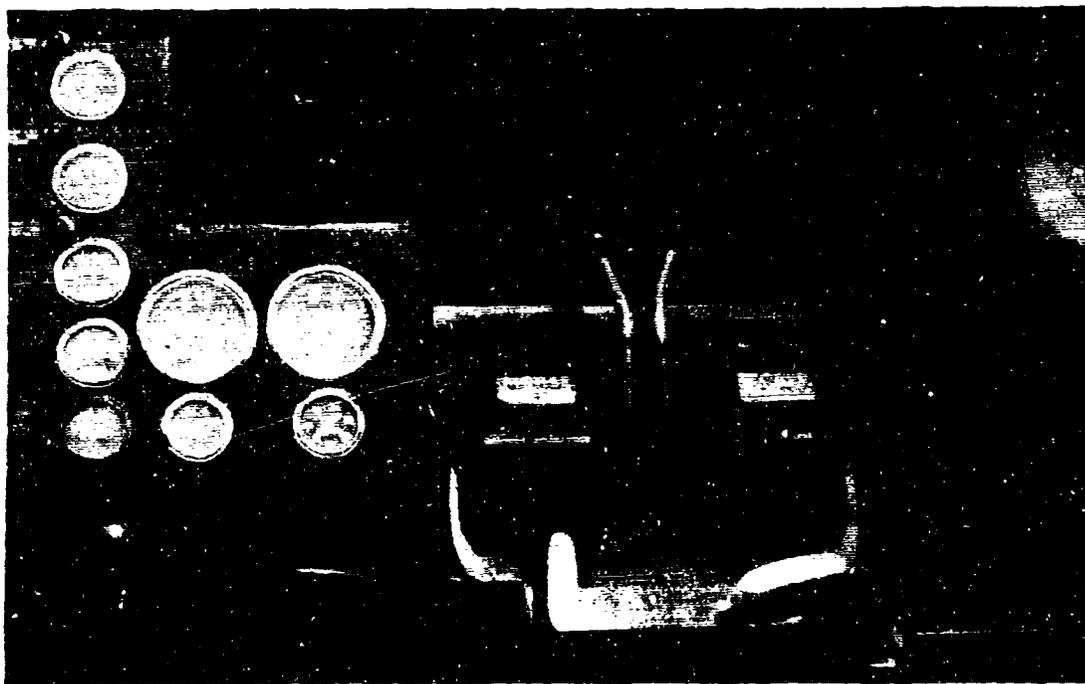
FIGURE II-12. Control Panel (Coxswain's Station).

The controls for the boat (see Figure II-12) were considered adequate by all personnel interviewed. Brighter control-panel lights for night illumination was the only change recommended. It was recommended that a higher wattage bulb with rheostat control be installed.

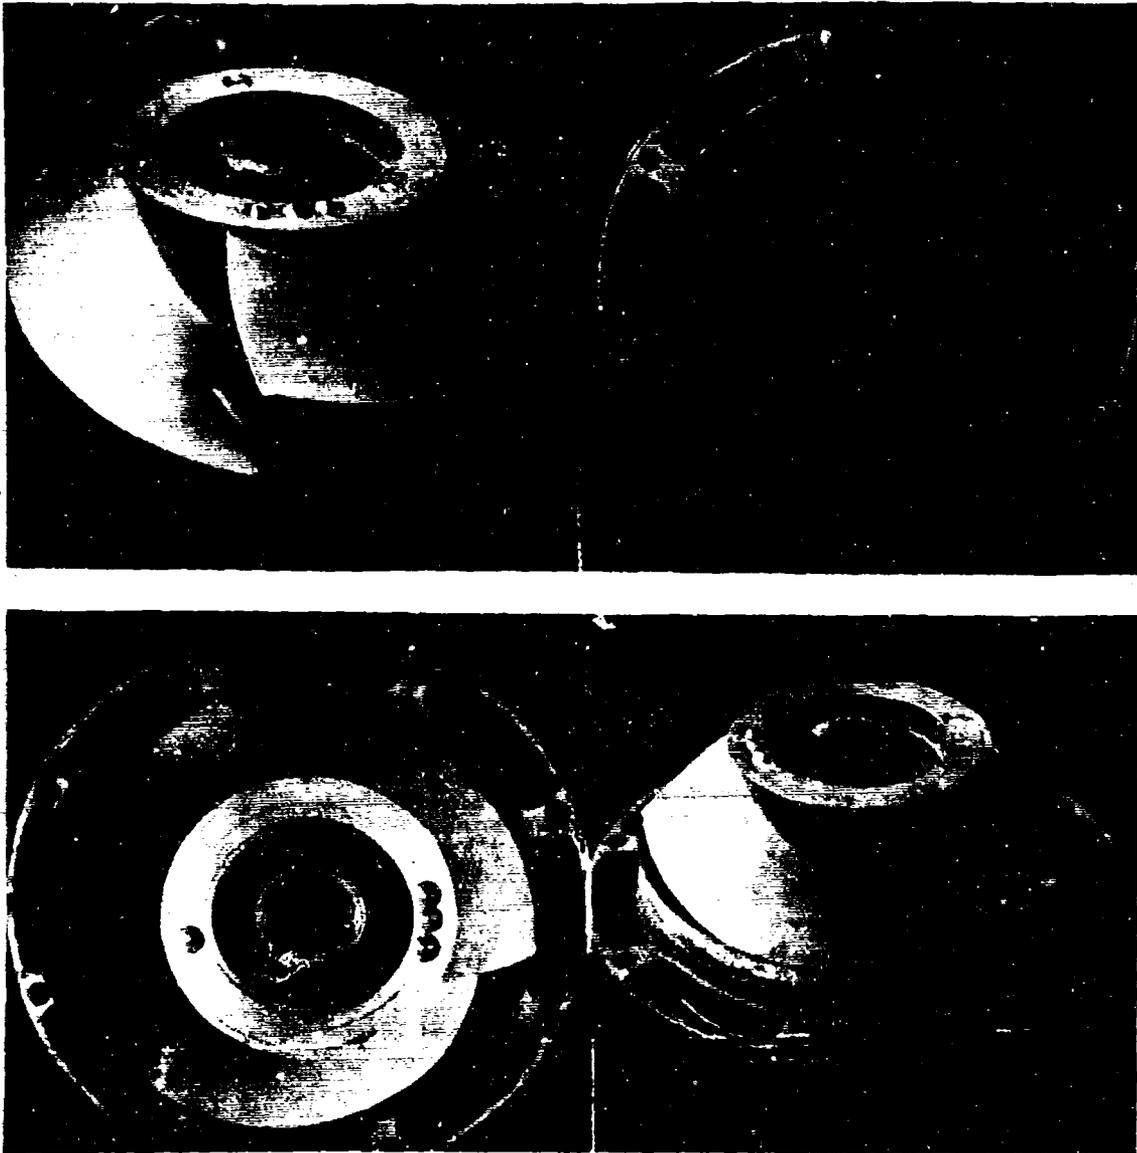
FIGURE II-37. MK2 Jacuzzi Pump Wear Plates With Impeller.

(a) Wear Plates, impellers, and bearings were the major causes of Jacuzzi pump failures. The stainless steel impellers and wear plates were susceptible to salt-water corrosion and pitting. Abrasive effects of silt and other foreign matter in the river water caused accelerated wear because special marine grease was not available.

(b) US Navy experiments revealed that wear plates made from a manganese/bronze alloy lasted much longer (an estimated four to eight times) than the standard stainless steel plates. A new stainless steel plate cost \$187.00, and a specially manufactured manganese/bronze plate cost \$250.00. Since requisition lead time on Jacuzzi pump parts was approximately 265 days, MMAV contracted for 20 locally manufactured manganese/bronze plates and found them to be more durable than the stainless steel wear plates (see Figures II-37 and II-38).
